On the Aging of Wood from Cultural Heritage

Shuichi Kawai

In Search of a Balance between Restoration of Cultural Heritage and Tourism Development

Shunsaku Miyagi
Representative Director, Byodoin Temple

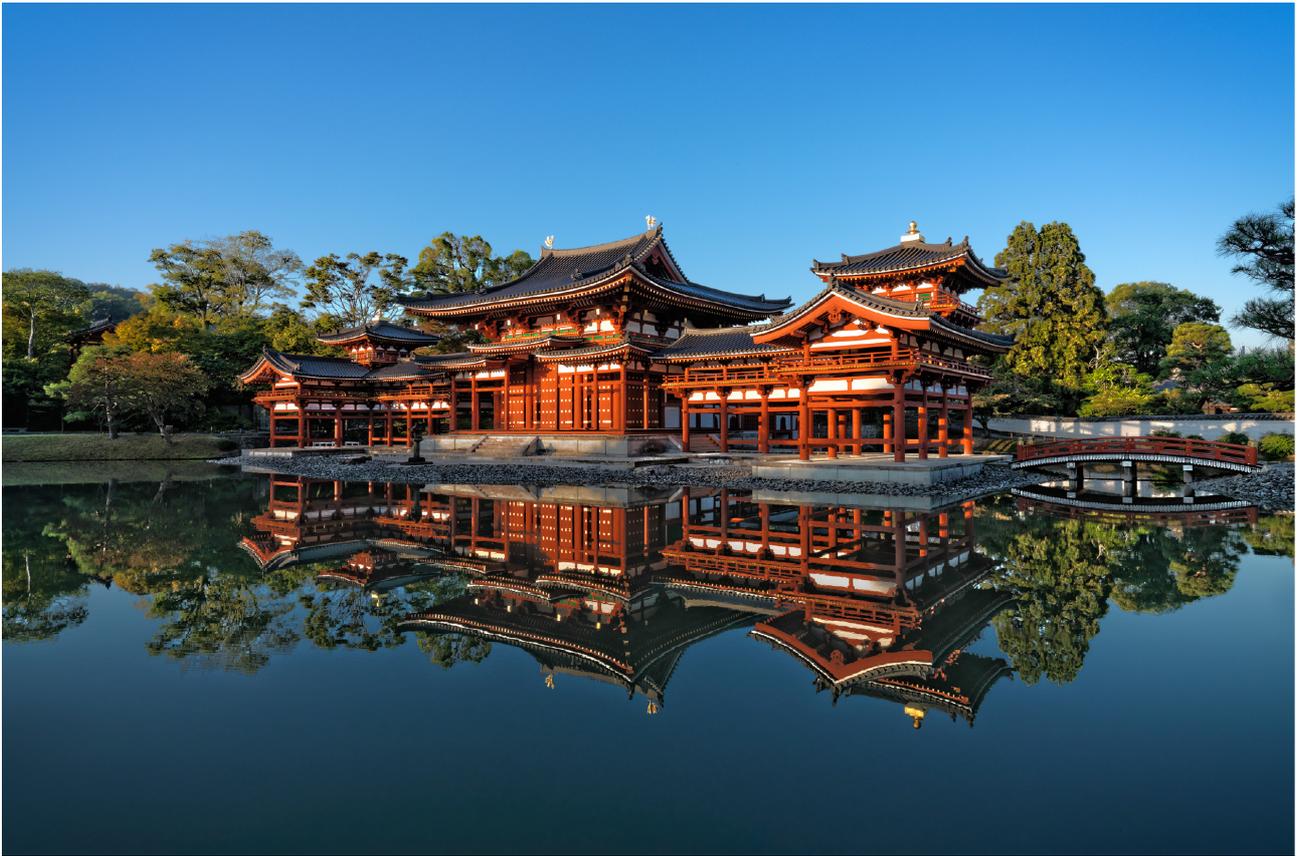
Phoenix Hall after the restoration works

Major restoration works of Phoenix Hall included wooden works of overall structure and coating its surface with original painting materials, replacement of roofing tiles by those of the original design, and some repair works for the metal ornaments. The original color and its primary ingredient on the entire wooden structure were identified through the chemical analysis of the residues found on the original tiles and wooden parts.

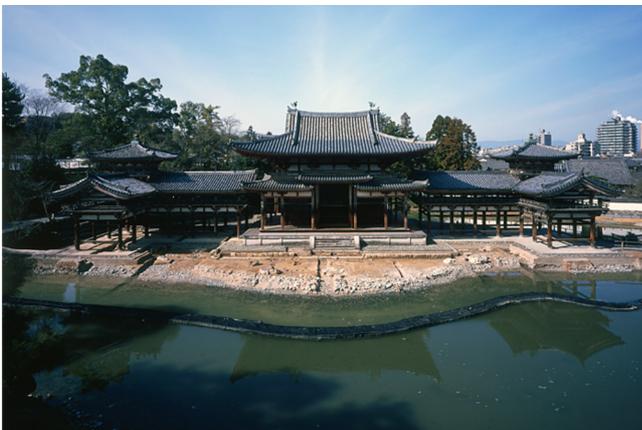
Archeological survey of the pure land garden

Based on extensive archeological excavation and surveys in and around the temple site conducted for over 7 years, the original form and visual images of the pure land garden has been revealed. Restoration works were conducted mostly on the shoreline of the island representing wave-washed beach along the pond on which Phoenix Hall has been set.

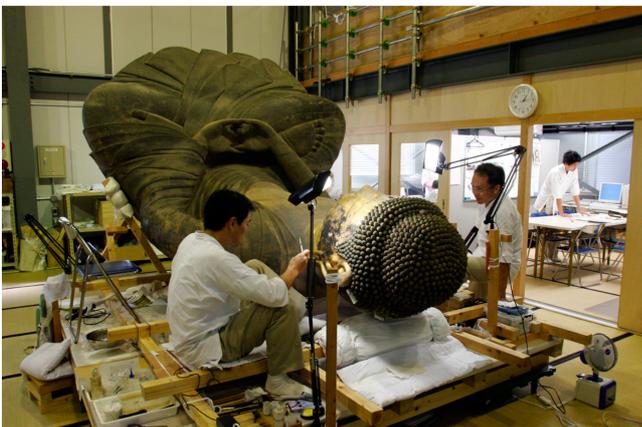
Repair works of Amitabha statue

Amitabha, the main statue in the Phoenix Hall, needed intensive care and repair works on its outer surface after having been exposed to the air for several hundreds years. Other statues and ornamental art works also to be repaired include 52 bodhisattvas or saints on the cloud, fine openwork of umbrellas on the ceiling, podium with lotus flower petals and the halo of Amitabha statue.
